Trapping by brake disc

QSE alert

Associated non-conformity code: NC2018001962

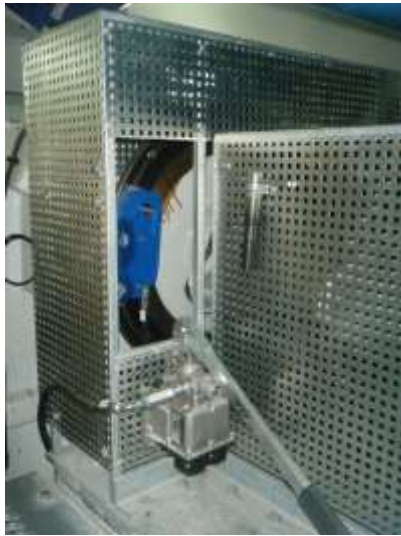
Root cause: The rotor block on this turbine model is completely manual, making it necessary to have a window for inserting the blocking bolt into the brake clip. The problem is that the dimensions of this window allow a hand to be fully inserted and reach the moving parts inside.

Close-up of the window in the brake disc protection for blocking the rotor.

- The rotor-blocking procedure is quite clear: **under no circumstances may the brake disc be moved by hand.** There is no reason to move a moving part, such as the brake disc or generator coupling by hand. If wind conditions are not right and the shaft cannot be moved by lowering blade degrees or a special tool for turning the shaft in the absence of wind is not available, then the operation must be postponed until wind conditions change.
- The **rotor** blocking window on the high-speed side **must be protected** in this turbine model in order to eliminate all possibility of being able to insert a hand and touch the brake disc. After investigating the accident, the Engineering Department's proposal to eliminate this risk is incorporated into Instruction 2018-000000049-INT.

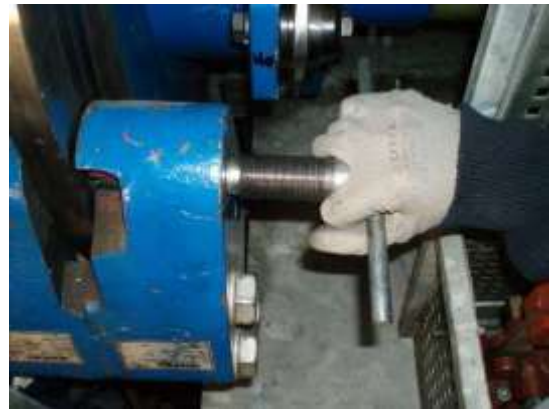
Close-up of the bolt-insertion operation, with the technician correctly holding the blocking "T".
