FATAL ACCIDENT IN CONTACTOR SWITCHGEAR PANEL

QSE alert

Associated non-conformity code: NC201708308

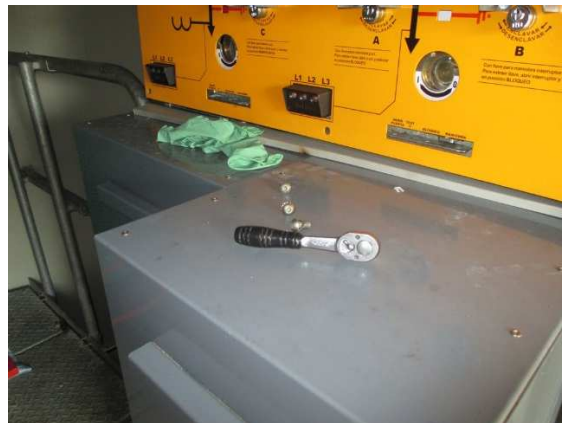
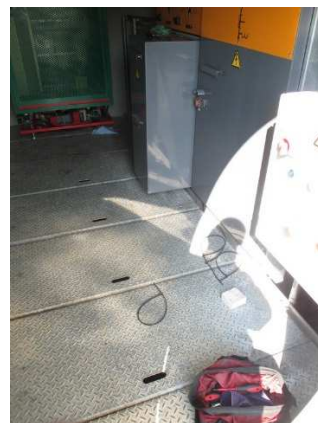
Close-up of the ratchet handle and the screws from the front panel of the switchgear found on the actual panel. It can be seen that the front panel is partially unscrewed. Inside the wind turbine with the tool bag on the floor.

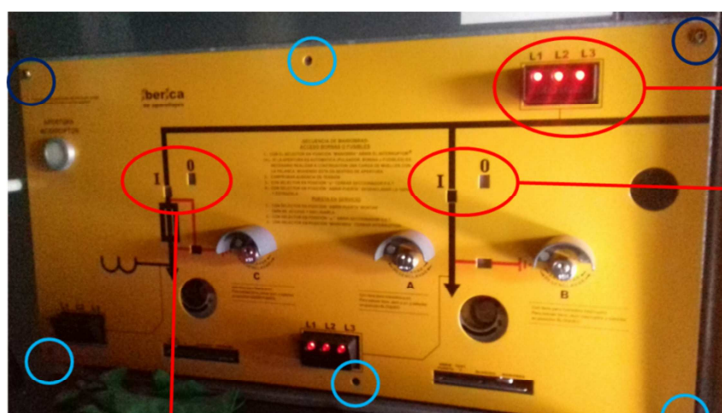
Leds que muestran que las 3 fases tienen tensión

Interruptor del línea posición cerrado

Sin tornillos

Tornillos flojos

Interruptor del trafo en posición abierto

Close-up showing the condition in which the switchgear panel was found.

- The discovered evidence indicates that the switchgear panel had been intentionally manipulated in order to extract the interlock key that protects the line switchgear panel. The investigation showed that by loosening the front panel on the switchgear panel and removing some of the screws, it becomes possible to force this panel to enable the lock barrel to be rotated and extract the keys without performing the isolation switch operation because when the panel and associated lock barrel are forced, the internal lock mechanism is freed and can be rotated.
- Non-compliance of the five golden rules: the power supplies were not opened, the lack of power was not verified and the installation was not earthed.
- None of the PPE required when working with electric shock hazards, which could have reduced the consequences of the accident, was employed during the operation.

- Improve the switchgear panel interlock system by installing an "additional special screw" in the front panel. This screw must require the use of a special tool to remove it and this special tool must be in the care of the Wind Farm Manager.
- All switchgear panel modules must be clearly and precisely identified: line switchgear panel, protection switchgear panel and contactor switchgear panel. This must be applied to all switchgear panels regardless of make and model.
- Establish a work procedure that defines how to transfer a turbine in those cases in which a work team is unable to repair a machine before their shift ends: in what conditions a turbine should be left, the minimum information that must be recorded about the operations carried out, where this information should be kept so that it is available to the next pair of technicians that comes to work on the machine etc.

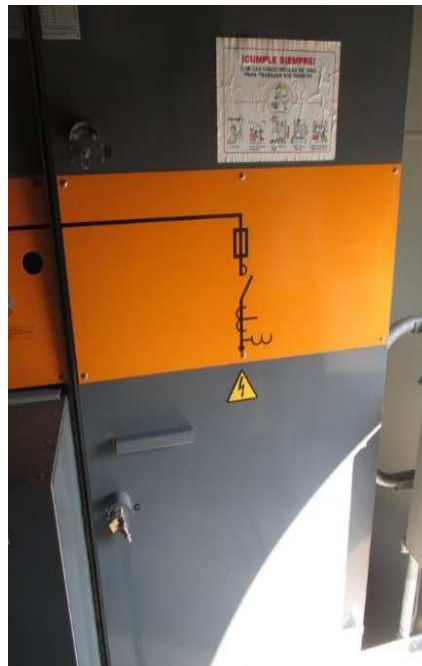
Close-up of the contactor switchgear panel door. The interlock keys (B and C) are correctly inserted into their locks.
