# Potential Hydraulic Injection

## QSE alert

Associated non-conformity code: EV.000000655

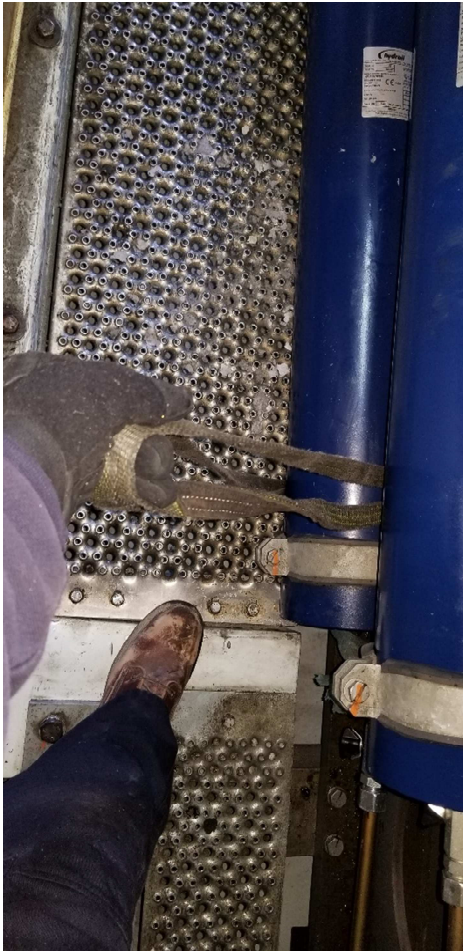
The residual pressure was held in the system by the flow regulator valve which had been closed. The sensor for the pressure on the touchscreen was not for the hydraulic side of the accumulator, but on the other side of a check valve at the hydraulic unit. The technicians did not have the procedure to change out the accumulator open or printed and relied on memory from five previous successful changes.

Nitrogen charged general accumulator

- Procedures must be open and consulted to ensure the correct and complete order of operations for all turbine (and substation) work. When LOTO is not specified (as was the case of these particular turbine vendor procedures), the Lead Authorized Person is trained and required to supplement the procedures to ensure proper LOTO and harmless energy levels.
- LOTO requires the use of a schematic or procedure or the Lead Authorized Person to set a zone of protection. LOTO must be performed every time a technician will be potentially exposed to harmful levels of energy. A second-person verification must be performed to ensure no harmful energy can be released.

- A gauge was not used to measure pressure in the proposed zone of protection.

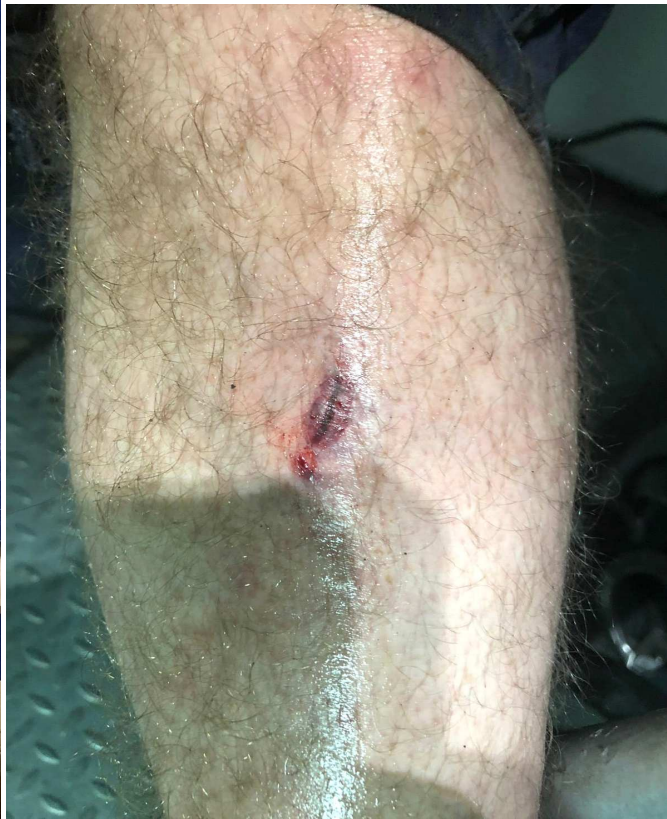
Two technicians were responding to the turbine for a hydraulic system fault. They had the tools and supplies for replacing the nitrogen filled general accumulator. One technician opened the circuit breaker to the hydraulic pump unit but did not apply a lock and the second technician did not verify the zone of protection or the absence of harmful energy within the planned zone of protection. The technicians erroneously used the touchscreen and determined there was zero pressure indicated in the system. A technician closed the flow regulator valve on the hydraulic side of the accumulator and then began to disassemble the hydraulic fitting and near the last thread the pressure released - spraying the area with hydraulic fluid and forcing the wrench to impact the technician's shin with sufficient force to break the skin and raise a welt.

Result of impact after first aid treatment
