# ELECTRIC ARC IN AW1.5 CONTACTOR MODULE

## QSE alert

Associated non-conformity code: NC2016004246

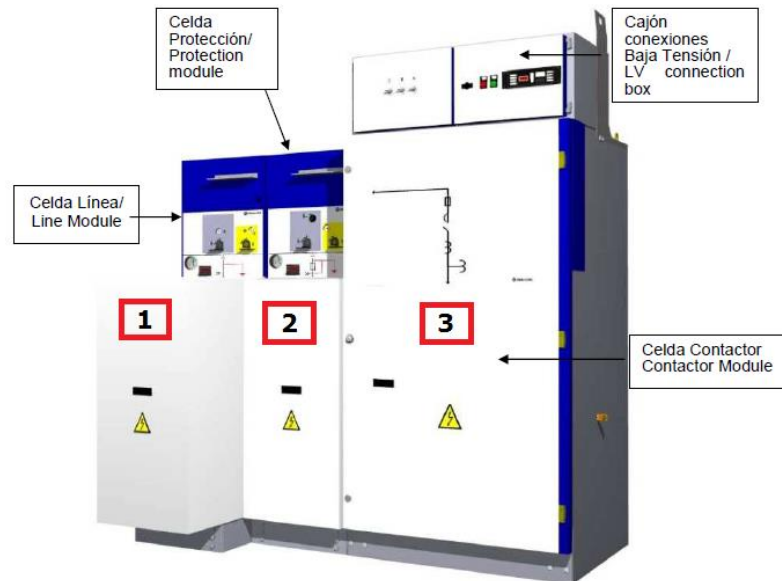
Front view of Cosmos modules (12 kV)

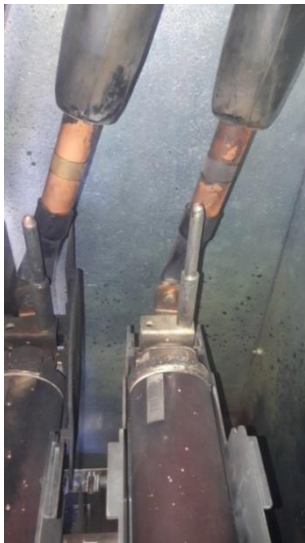
Figure 1

The short circuit, which tripped connection 4, damaged the stator contactor (Figures 1 and 2) and the portable earthing set (Figure 3).
