# Nitrogen bottle falling from the hoist

## QSE alert

Associated non-conformity code: NC 2016003600

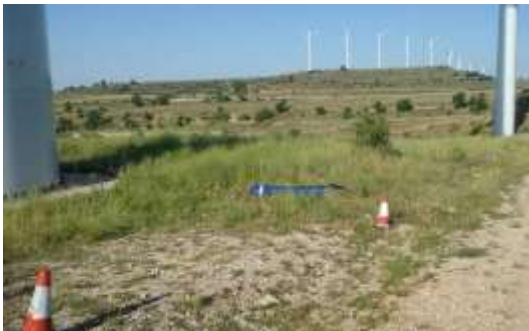
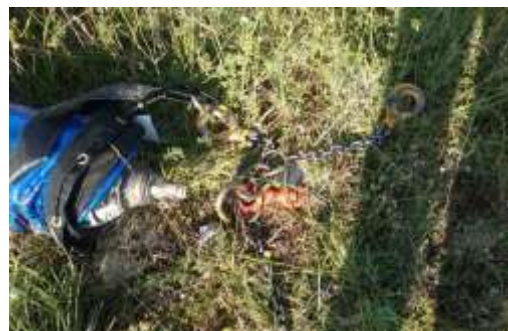
When the load was at the maximum elevation of 80 metres, just before taking it into the nacelle, it was loosened and fell to the ground. It was later found that one of the chain links had broken. The hoist and the chain were sent to the manufacturer for an inspection of the affected components.

Condition of the load after the fall.

- Under no circumstances whatsoever, shall personnel remain within the vertical projection of a hoist with suspended load. As soon as the load is attached to the hook, immediately leave the area of risk.
- Remember that the nacelle vertical projection must be clearly indicated so that it is not invaded by third parties, especially when loads are being lifted by the hoist.
- Ensure that the loads are correctly attached to the hook and that all tools are properly secured inside the bag (without any risk or over-turning or loosening).
- Remember that any lift accessory that has suffered a fall must be taken out of service until it has been inspected by a competent person.
- Pay attention when leaving the Ground to go outside the wind turbine: Previously check that the wind turbine hoist is not being used. If it is in use, wait inside until the load has been completely lifted or lowered.

Furthermore, the following checks must be made every day, prior to using the hoist.

- Ensure that the hook security catch is in good condition.
- Examine the chain or cable for deformations, worn parts and broken wires etc, which raise doubts about its strength that could affect correct hoist operation.
- Ensure that the maximum permitted load for the hoist is not exceeded during use.
- Check for correct operation of the pushbutton unit controls.
- All lifting elements must be certified and all periodic inspections up to date, at least once a year.

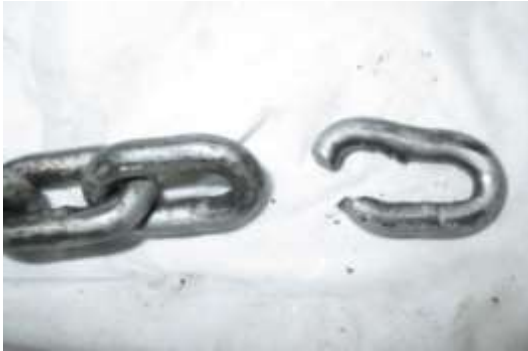
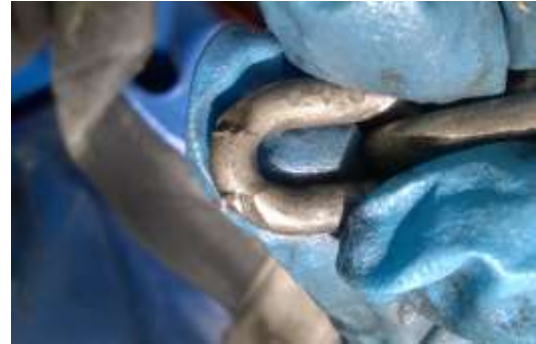
Affected links in the hoist chain. Counting from the hook, link 6 was broken and link 7 was marked.
