Trapping by brake disc

QSE alert

Associated non-conformity code: NC2018001962

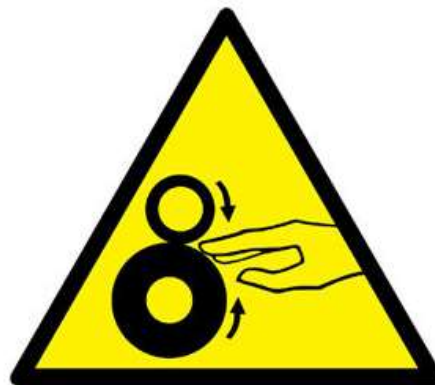
Root cause: The rotor block on this turbine model is completely manual, making it necessary to have a window for inserting the blocking bolt into the brake clip. The problem is that the dimensions of this window allow a hand to be fully inserted and reach the moving parts inside.

- The rotor-blocking procedure is quite clear: **under no circumstances may the brake disc be moved by hand.** There is no reason to move a moving part, such as the brake disc or generator coupling by hand. If wind conditions are not right and the shaft cannot be moved by lowering blade degrees or a special tool for turning the shaft in the absence of wind is not available, then the operation must be postponed until wind conditions change.
- The **rotor** blocking window on the high-speed side **must be protected** in this turbine model in order to eliminate all possibility of being able to insert a hand and touch the brake disc. After investigating the accident, the Engineering Department's proposal to eliminate this risk is incorporated into Instruction 2018-000000049-INT.
